**SAS Superstructure**

**Daily Diary Report by Bid Item**

Contract No.: 04-0120F4

Diary #: 063 Const Calendar Day: 267 Date: 02-Jun-2010 Wednesday

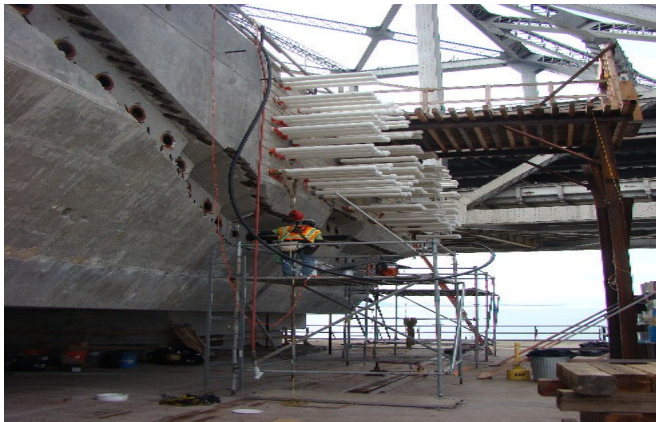
Pushing strand into continuity tendon 16B from the west end of the cap beam.

- Pushed all 27 strands from pack #8185 for continuity tendons E15B, E16B, E27B, and E28B which need to be stressed first per submittal 1529R01. Anchorheads and wedges were placed on both the live and dead ends of these tendons in preparation for stressing operations tomorrow morning. It should be noted that these tendons are on the bottom row of OBG Lift 1E which are stressed as soon as possible due to the thermal moment believed to be acting at the end of OBG lift 1E. Stressing these tendons would "lock-in" the bottom of the OBG into the cap and restrict the differential movement prior to the placement of concrete (lift 2) at the W2E construction joint.

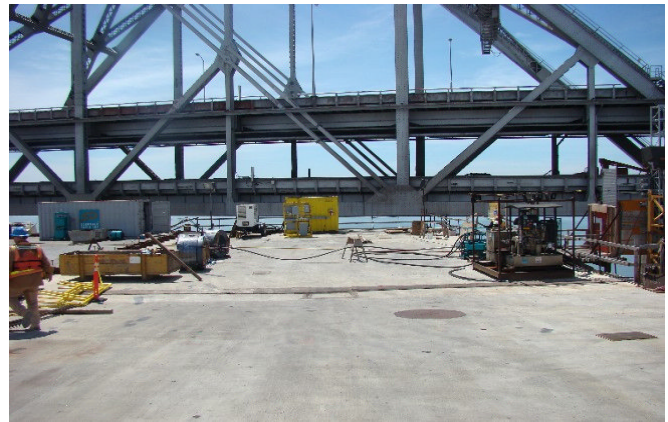
Strand pushing equipment and operation on top of the W2 cap beam.

- Mobilized the equipment used for strand placement, post-tensioning, and connex box on top of the W2 cap beam near the E-Line continuity tendons. The connex box is a storage unit for all the miscellaneous small tools and materials. It also should be noted that the equipment and connex box were shipped to the jobsite yesterday in addition to a few strand packs.

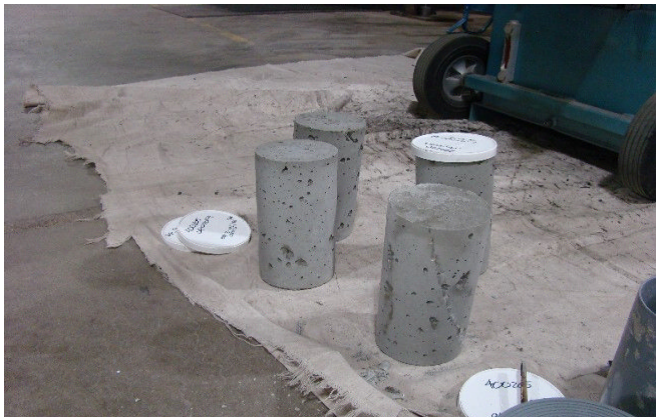
Voids seen on the 4"x8" cylinders after stripping the plastic in preparation for compressive tests.

- Retrieved and transported to the Caltrans Richmond material lab 4-4"x8" cylinders for compressive strength at 10hrs and 2-6"x12" cylinders for compressive strength at 1day for the W2E closure pour lift 1 SCC. The 4-4"x8" cylinders were tested at the Richmond lab by Rob Ramos (Caltrop) and the 6-6"x12" cylinders were brought by Rob to the Sacramento Translab. John Beede and myself observed the compressive strength tests of these 4 cylinders conducted by Rob at the Richmond lab. The cylinders couldn't be broken since the capacity of the machine was 40,000lbs or 3,100psi for these cylinders. Jim Davidson informed me later in the day that Smith Emery was reporting compressive strengths at the same concrete age of approximately over 6,000psi. This would explain why the machine at the Richmond lab couldn't break the cylinders.
